Wrong Surface Landings

Kim Cardosi, Ph.D.
kim.cardosi@dot.gov
April 10, 2019

Sources of Risk of Wrong Surface Landings

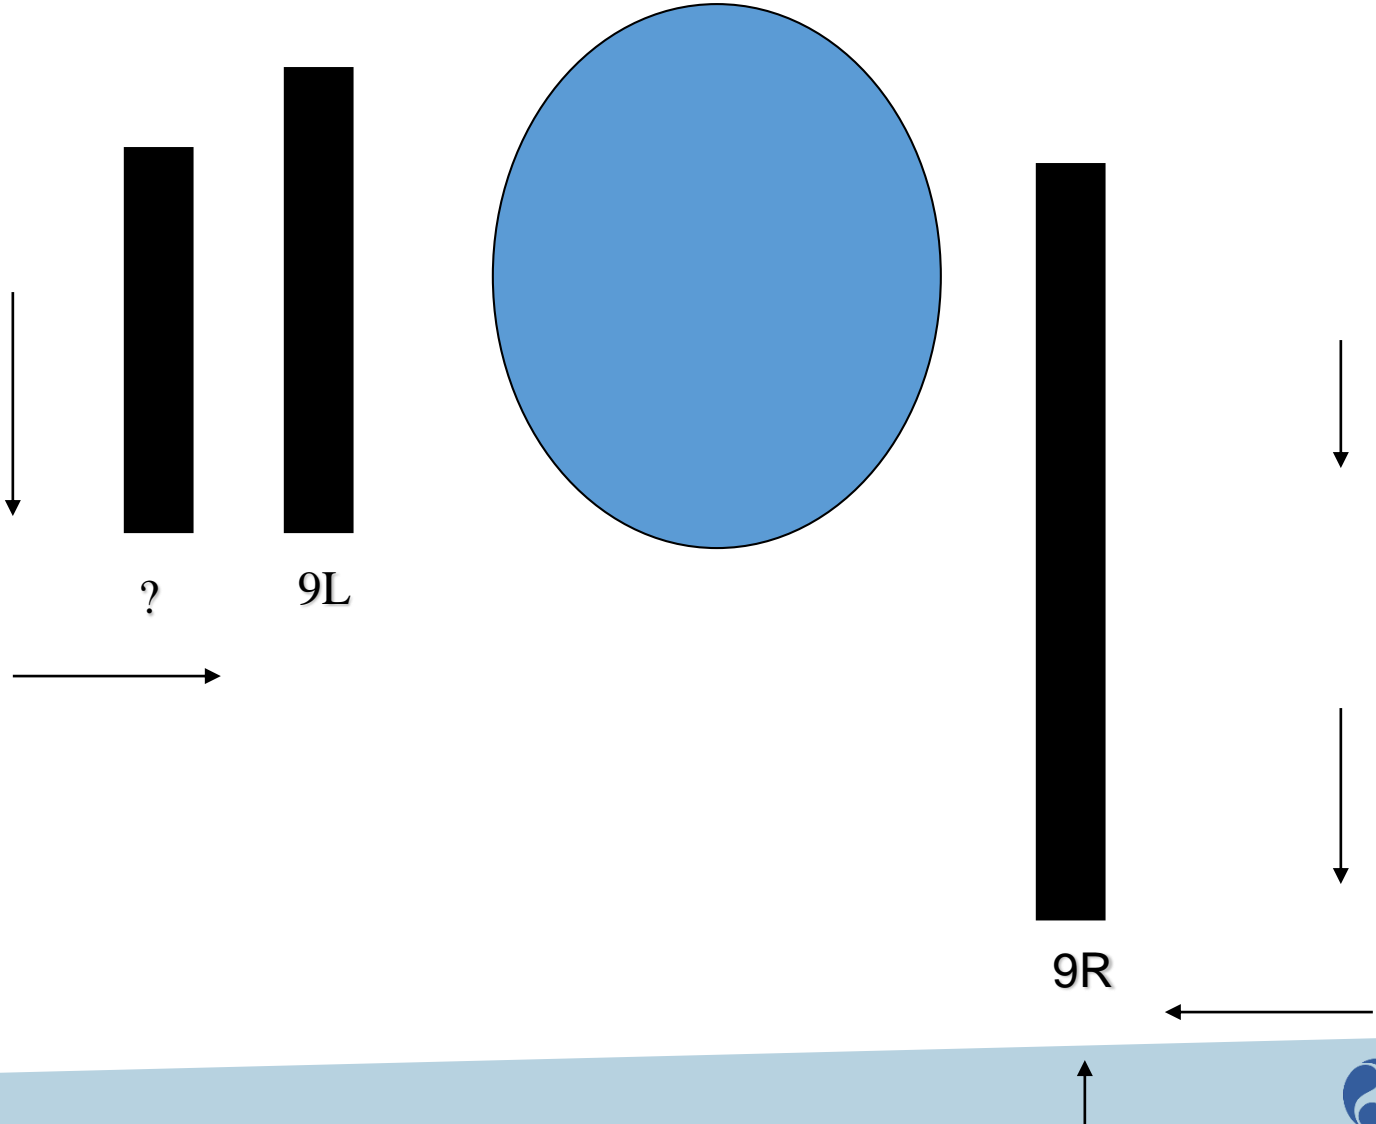
MIA parallels

- Laws of Perceptual Grouping
 - Pre-attentive grouping – help predict how people divide items (runways) into perceptual groups (pairs)
 - Proximity
 - Similarity
- Pilots may not “see” all of the runways due to visibility conditions and/or attentional tunneling.

- Proposed Designation: Keep 9L and 9R as is
 - Engineering proposed designation for new runway as 8
- ICAO designation would be 9L, 9C, 9R
 - does this match expectations?

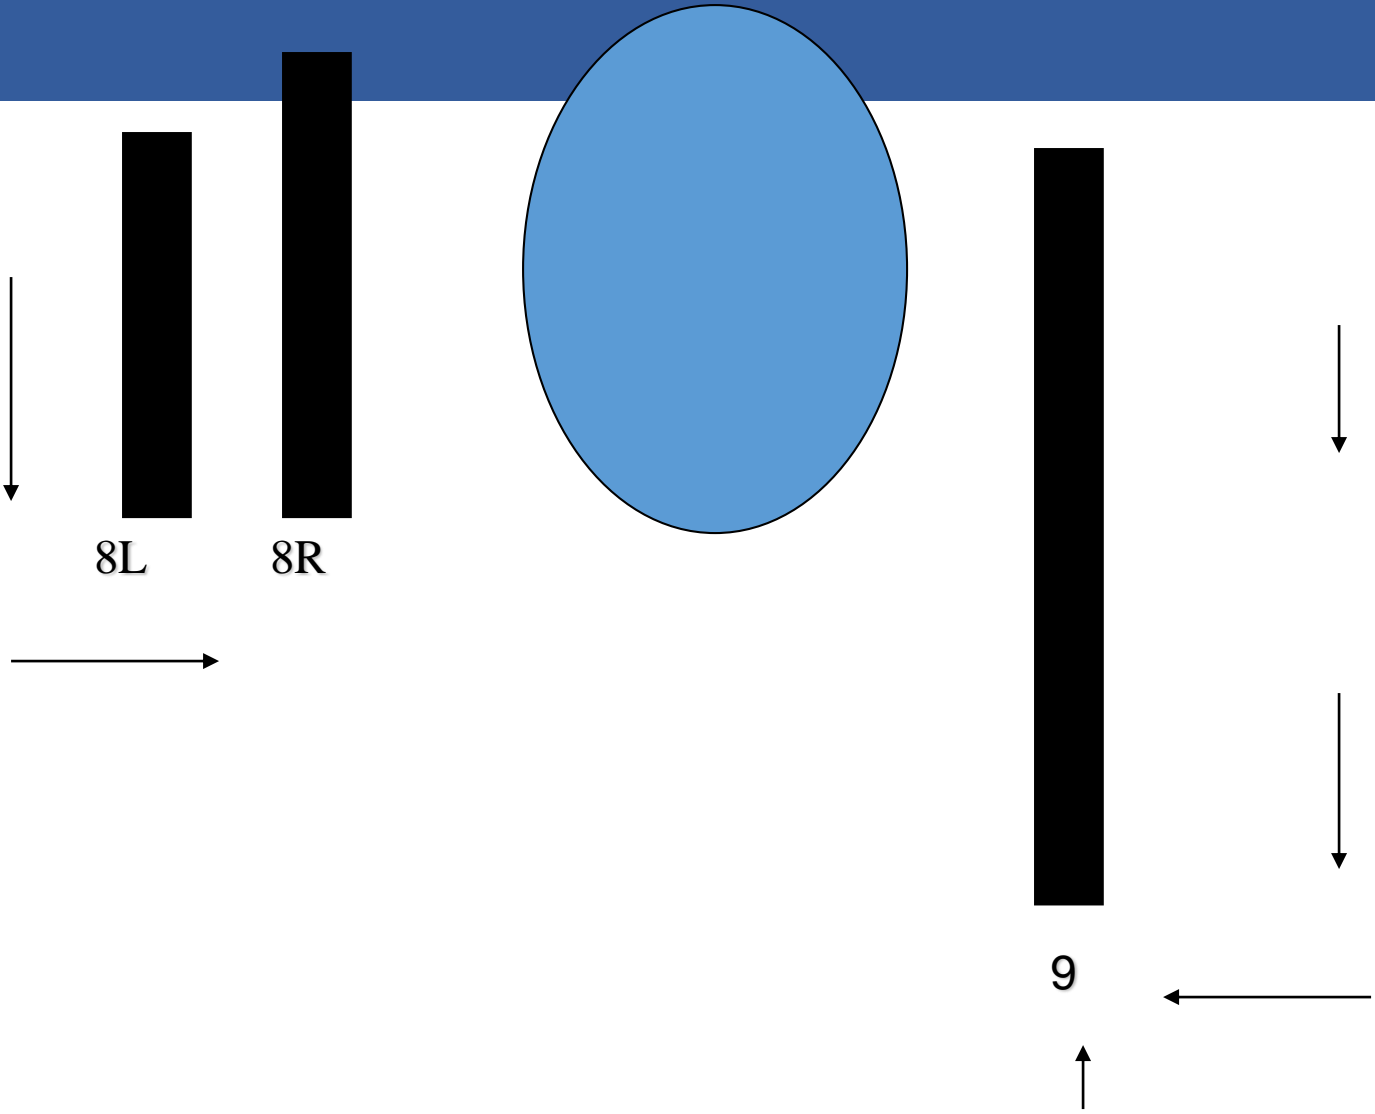
Final Designations

- To minimize the changes of pilots landing on the wrong runway – set up reality to match logical expectations.

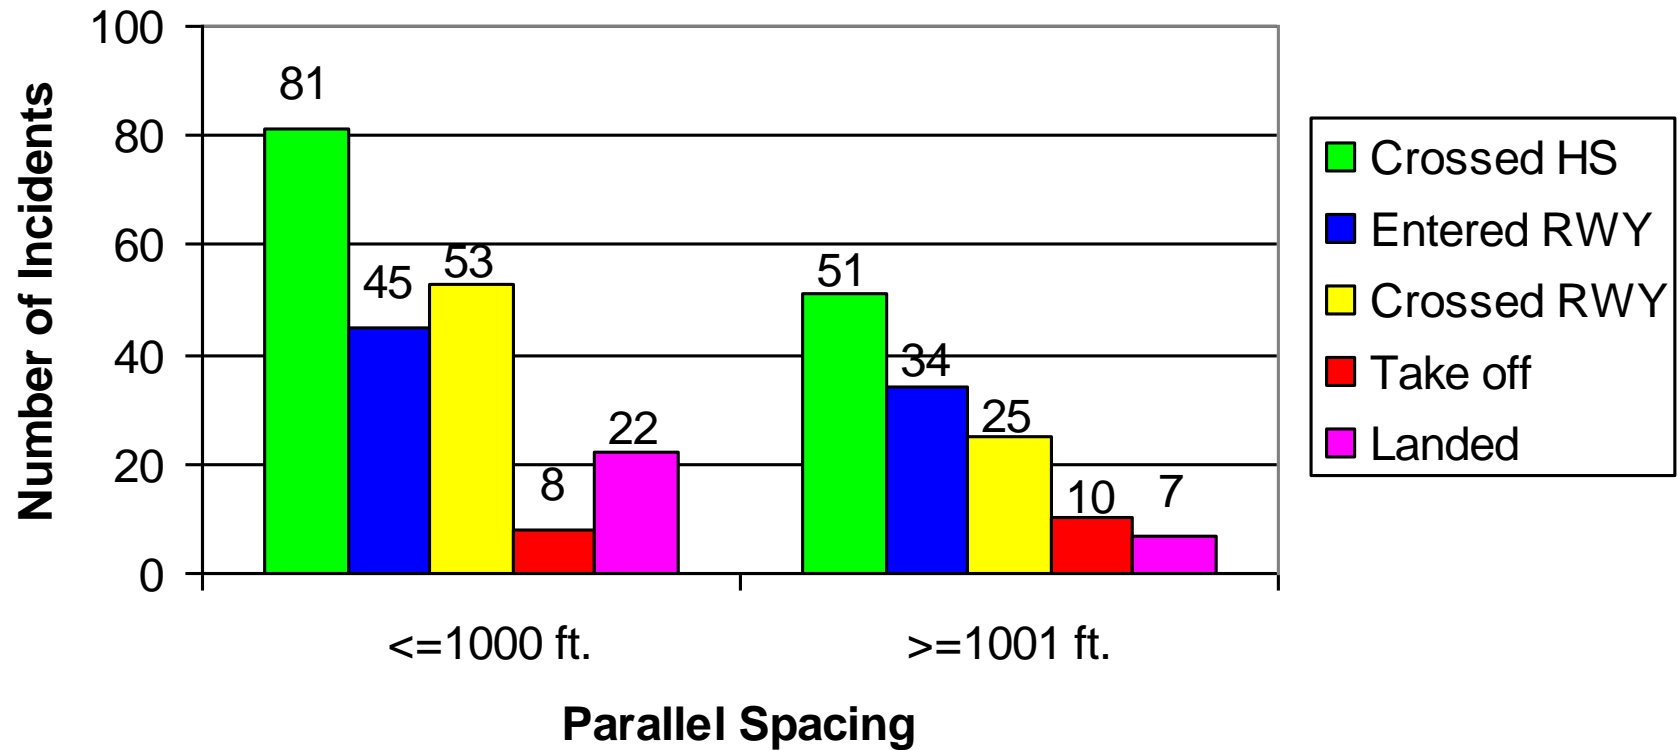
FY04-FY07: Select Activity Without Authorization by Parallel RWY Spacing

- Most wrong surface landings involve surfaces parallel to the assigned runway
- Closely-spaced parallels (less than 1000' centerline-to-centerline) are particularly problematic
